Western rails electronic edition

5PS6 intermodal Curtin derailment 30th January photographic coverage special

ISSUE SEVEN FRIDAY 6TH FEBRUARY

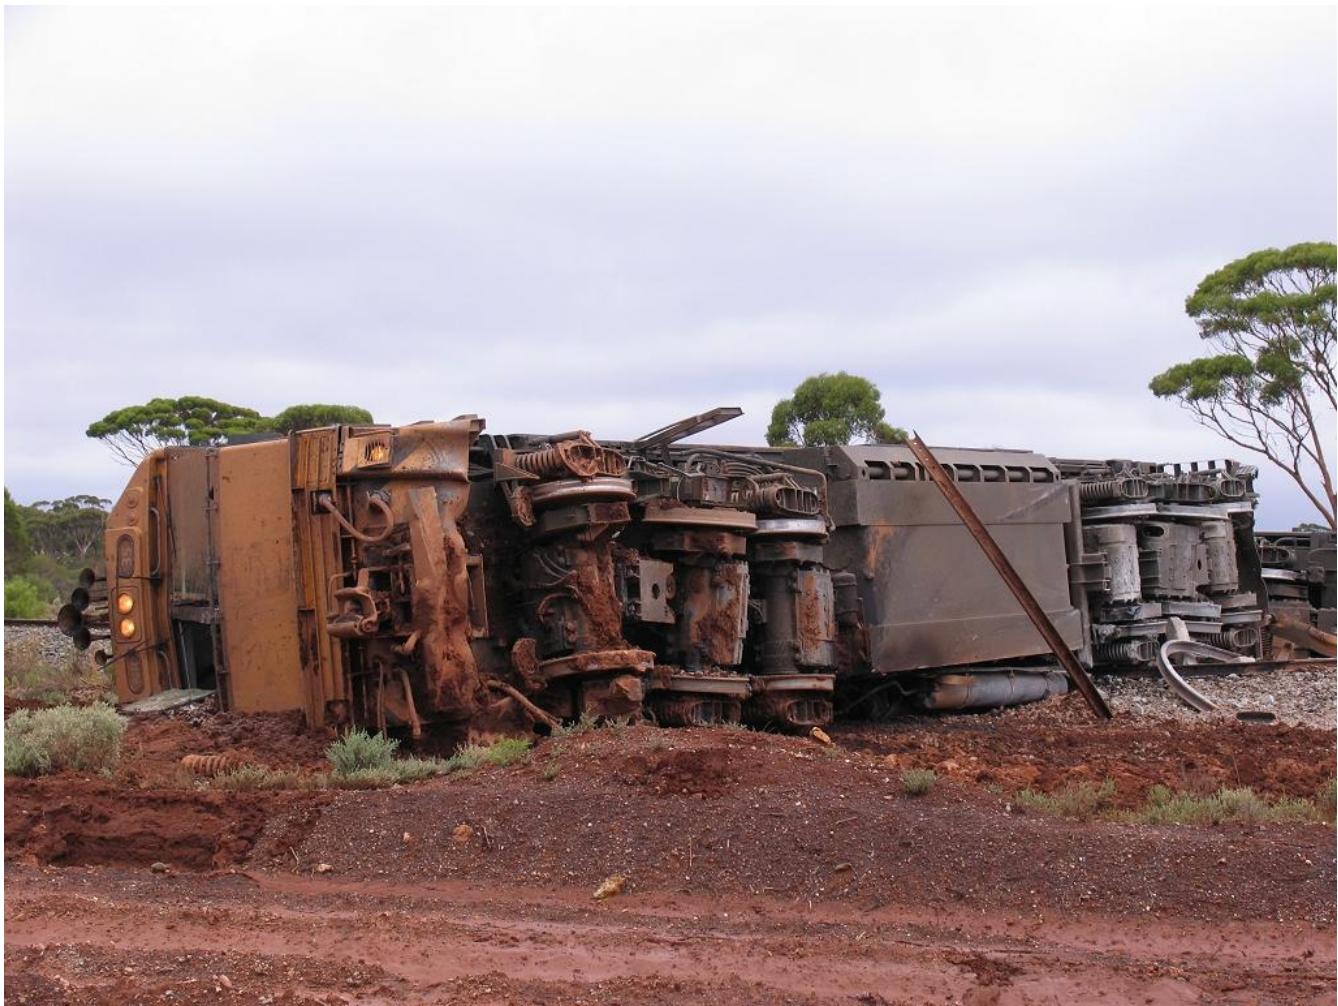
NR35 on its side after derailing at 1738.600km Trans Australian Railway in Golden Ridge-Curtin section on January 30th where some 100m of track had been flooded and undermined in a washaway. Fortunately the crew only suffered minor injuries. Note that the headlight is still on. Photo John Bollans

Following stabilisation of the site by the fire brigade and ground drying out recovery work commenced with earthworks being prepared to construct a deviation around the derailment site on the south side of the line being seen as quickest way to reopen Trans line. The part of the train that did not derail was hauled back to Kewdale on 1st February by NR121 & NR1. Trucks began dropping dirt for rail bed on 1st February where the new deviation would be built while rail sleepers and rail were also delivered. Ballast trains were run on the east of derailment site by 80s6, NA1874 and RL307 where repairing other washaways on the track were undertaken. By the evening of 4th track laying on the deviation was nearly completed with ballasting to commence at 2100. Ballasting, tamping and aligning the track continued though the night into the next day and night with the line reopening at 1115 on 6th February having a 20km speed restriction on the deviation and repaired washaways. Recovery of containers, wagons and the locomotives continues. Jo B

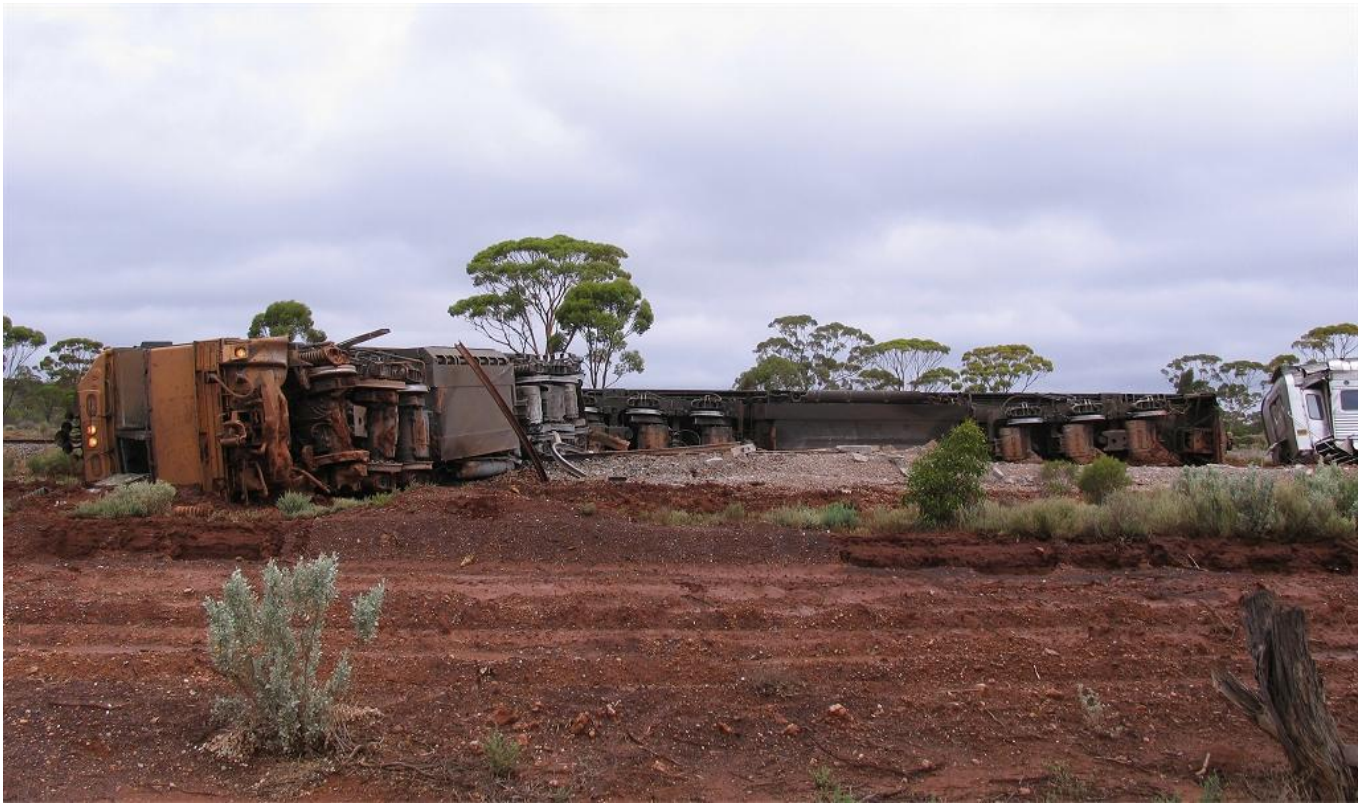
As a result of the 30th January derailment NR35 and NR51 were both on their sides. Photo John Bollans

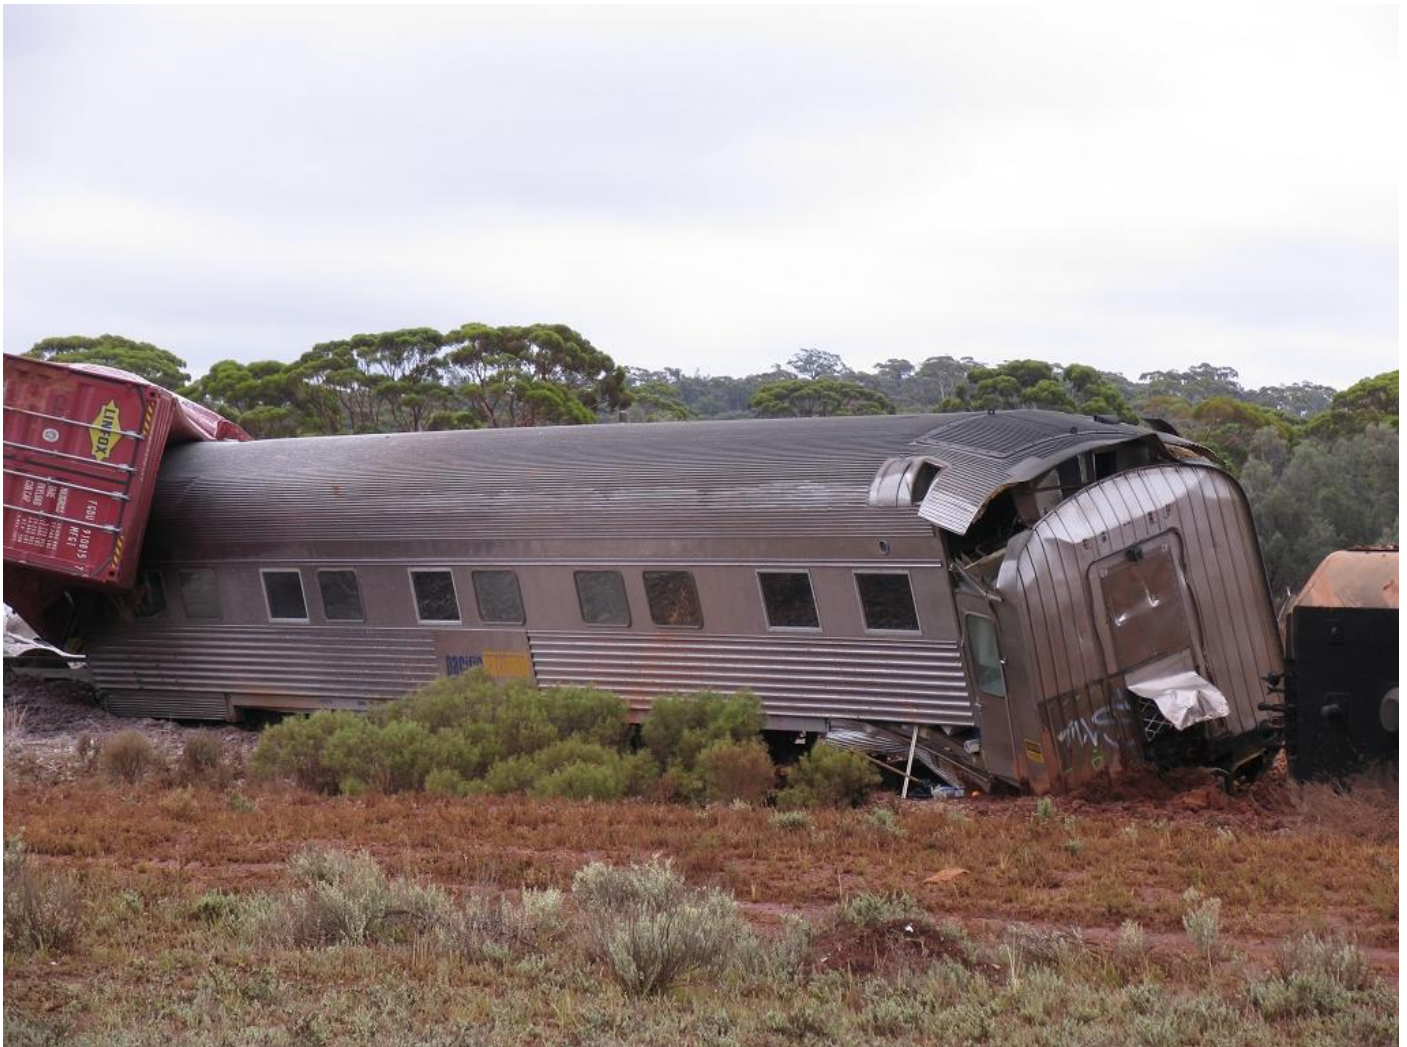
The crew car RAZY 289 though extensively damaged remained upright showing its strength of construction bending the empty container that landed on its roof in the 5PS6 derailment 30th January. Photo John Bollans

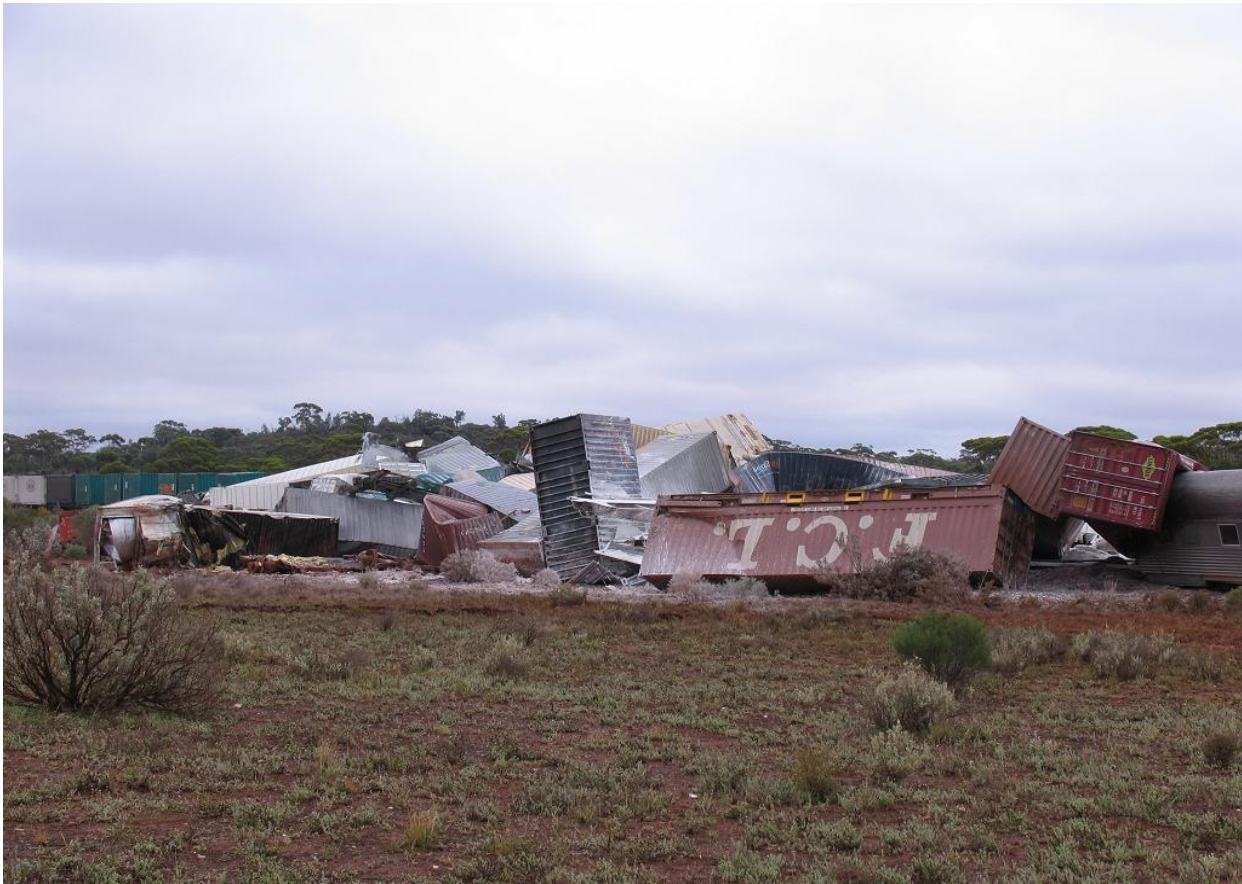
Derailed wagons piled up behind the crew car with the part of the train that didn't derail in the background. In the foreground is where deviation around the derailment site is to be built. Photo John Bollans

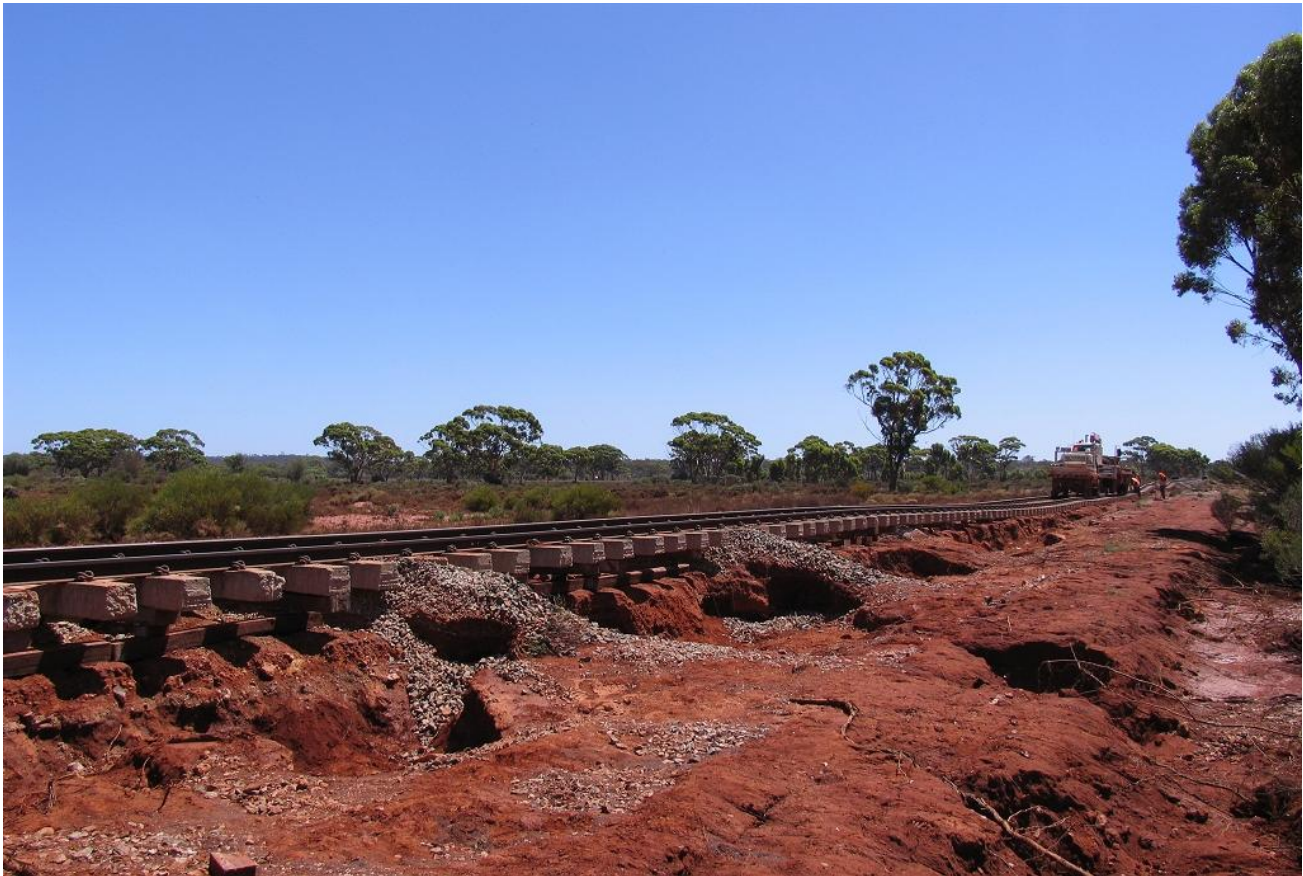
Washaways with the deep scouring of the embankment and track bed are east of the 1738.600km derailment site with these washaways under repair on 1st February. Photo John Bollans

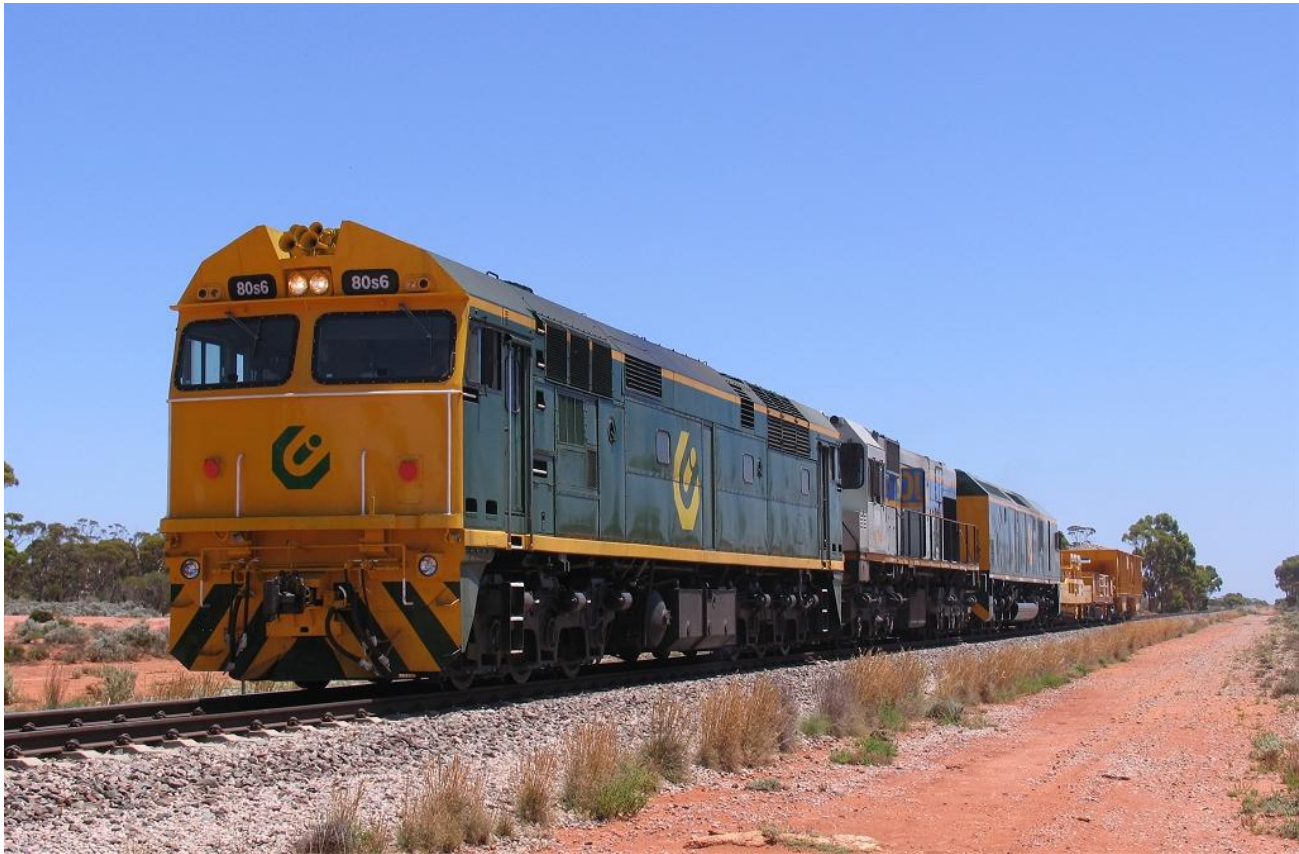
80s60, NA1874 & RL307 on two wagon ballast train, ballast plough east of derailment near Curtin waiting to propel to another washaway site and ballast as part of Trans Lines repair 1st February. Photo John Bollans

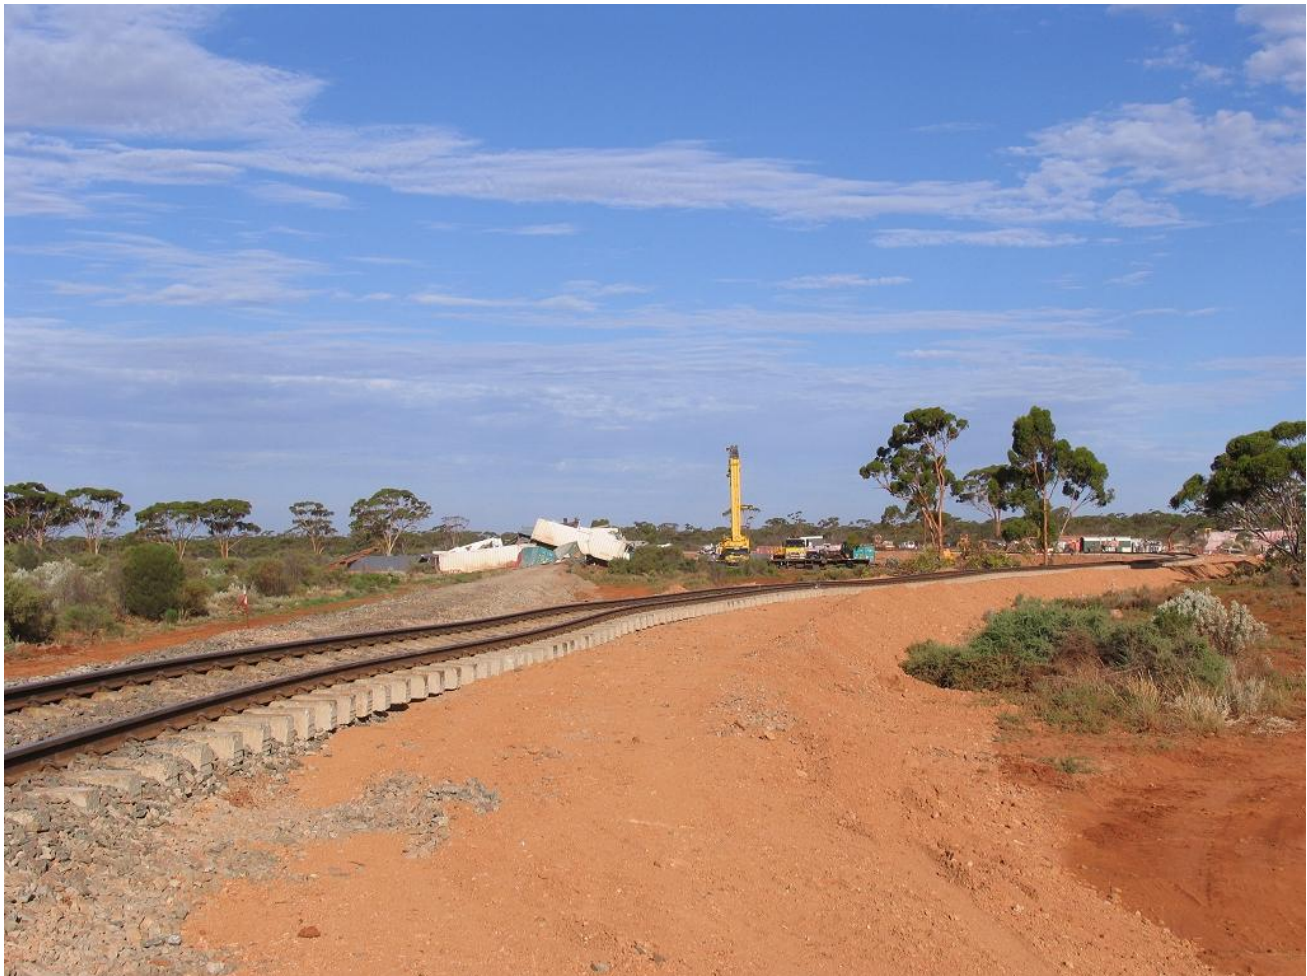
Completed deviation and slewed main line track at 5PS6 derailment on 4th February. Photo John Bollans

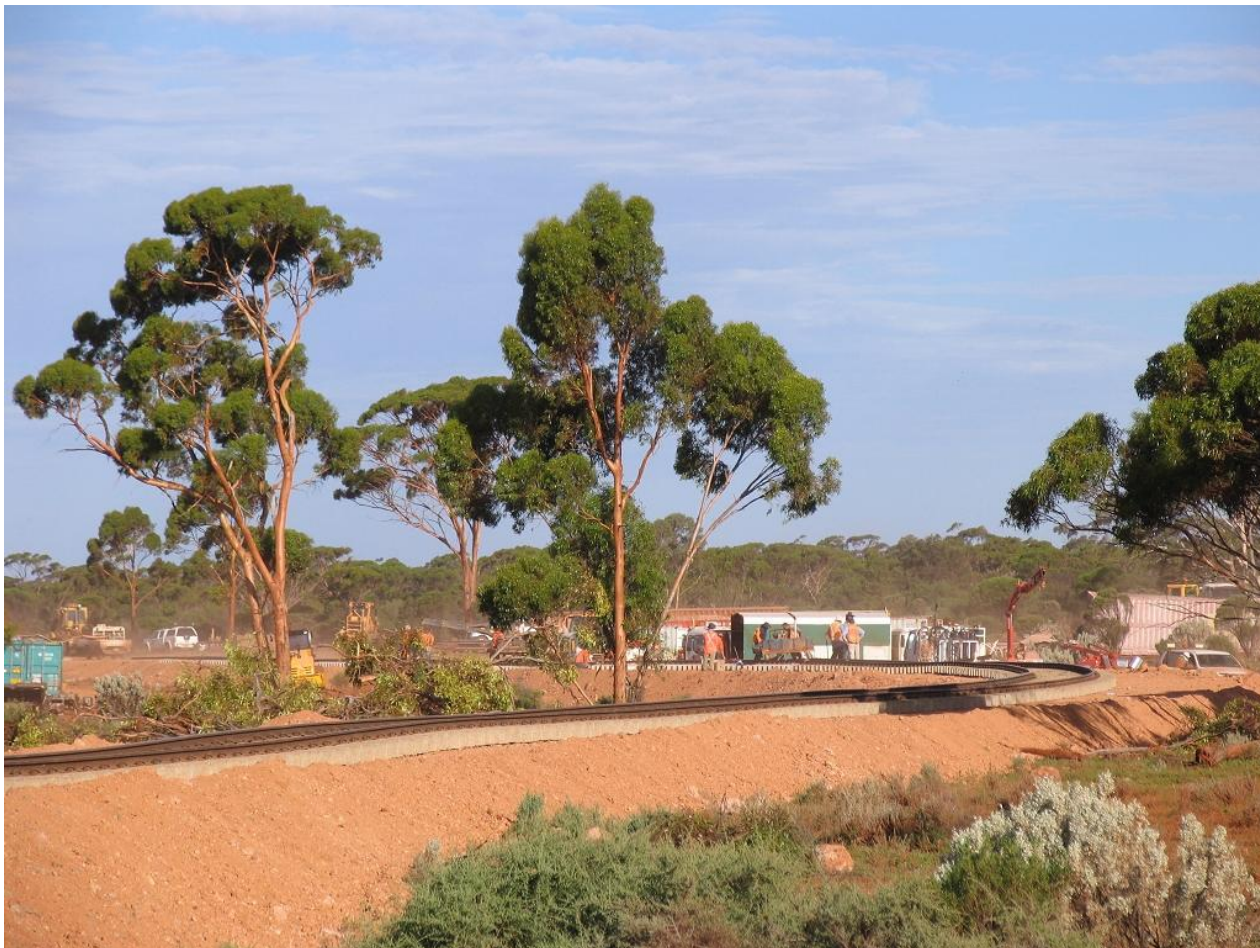
Unballasted deviation at 1738.600km where ballasting commenced at 2100 on 4th. Photo John Bollans.

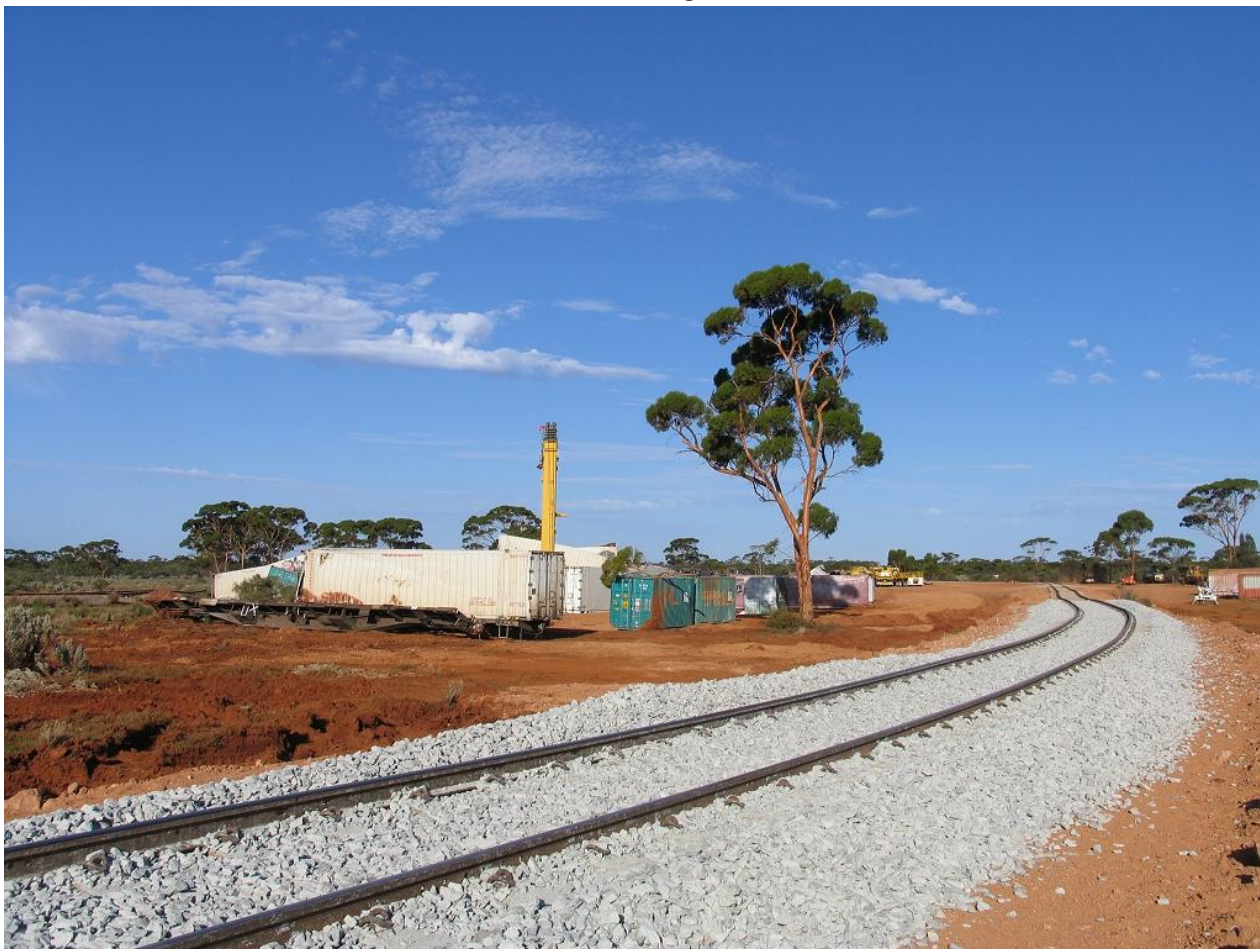
Partially ballasted deviation with recovery of 5PS6 loading underway on 5th. Photo John Bollans
